SIGNATURES		DATE	TITLE
DRAWN MJC		08/16/22	WORN RADIUS INSPECTION ILLUSTRATION
CHECKED RCN		08/16/22	
ENGR.			
DIMENSIONS ARE IN INCHES		TOLERANCE UNLESS OTHERWISE SPECIFIED:	
UNLESS OTHERWISE SPECIFIED		DECIMAL ± 0.015	
ECN 22530		FRACTION ± N/A	SIZE A
		ANGULAR ± N/A	DRAWING NO. 00726012
			SHEET 1 OF 1

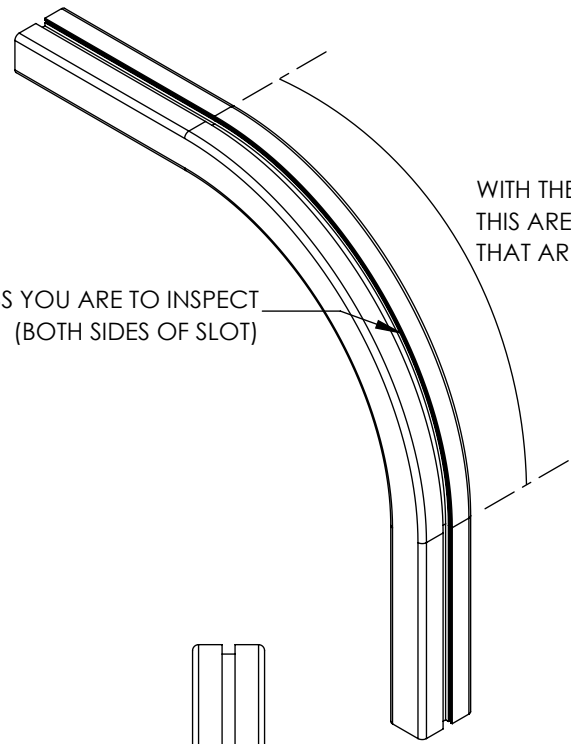
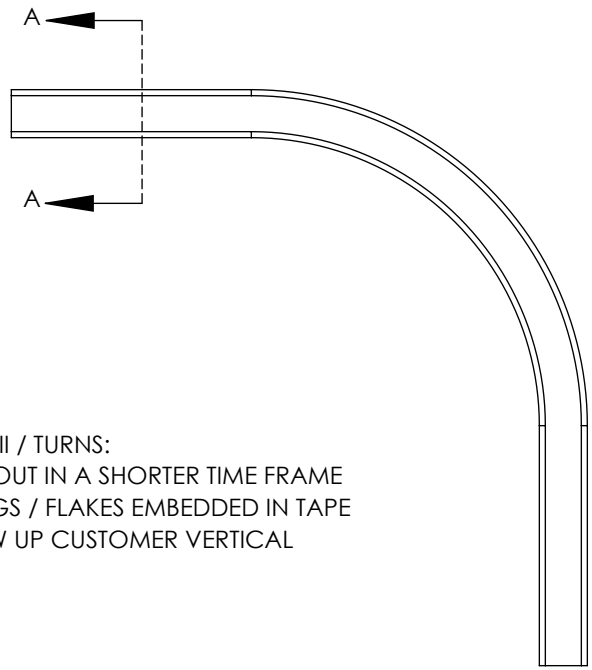
SYMPTOMS OF WORN RADII / TURNS:
 DRIVE TAPE WEARS OUT IN A SHORTER TIME FRAME
 ALUMINUM SHAVINGS / FLAKES EMBEDDED IN TAPE
 CARRIER RUNS SLOW UP CUSTOMER VERTICAL
